1965 - 69 Corvair Front Suspension Replacement Lower Control Arm Bushing Failure Problem

By Bob Nichols

Effective April 18, 2025

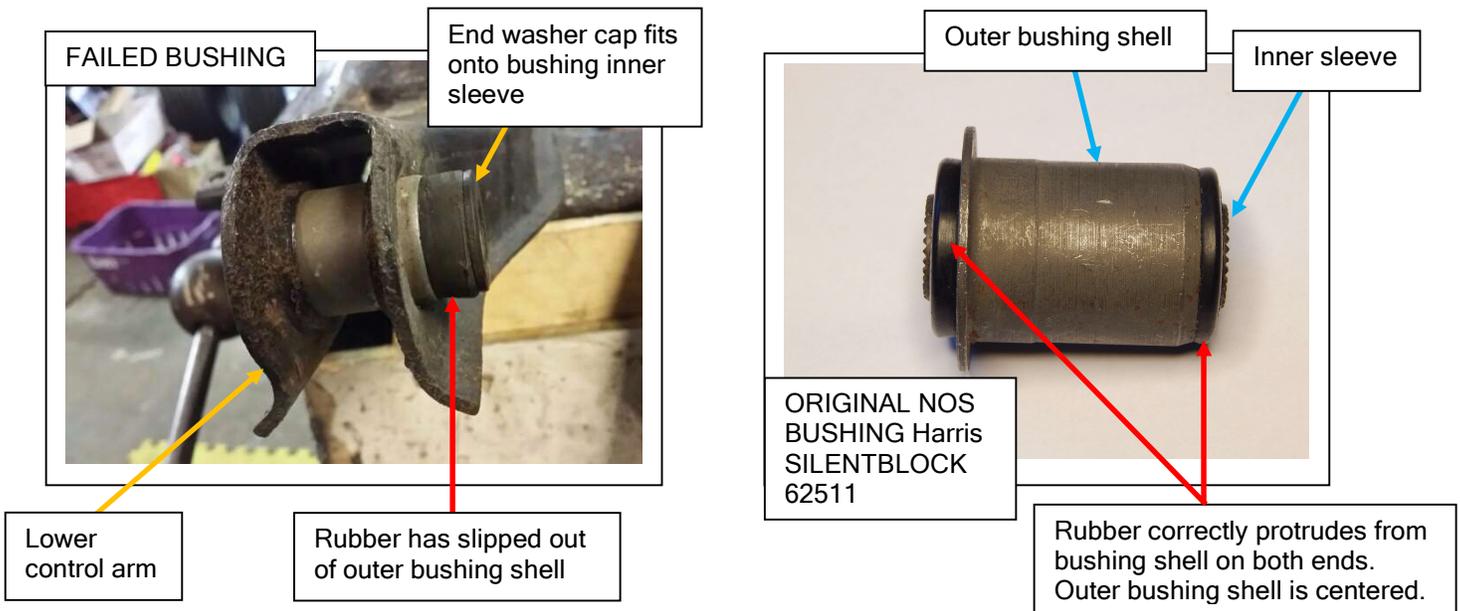
THE PROBLEM: OEM (original equipment manufacturers) no longer make the 1965 - 69 front suspension lower control arm bushing. Corvair parts vendors are now selling alternatives. Owners reported problems with the new replacement bushings failing within a couple years or a few thousand miles. The bushing rubber, or elastic material, fails due to an incorrect design and the lower control arm, instead of being isolated by rubber, contacts the crossmember, metal on metal. This failure happens much sooner than it should compared to the original bushing service life. Failure symptoms reported are clanking or banging while stopping or when going over bumps, and unusual tire wear. When the owner, or a mechanic, inspected the suspension they found the lower control arm was contacting the crossmember frame because the bushing elastic material had not kept the control arm centered in the crossmember. On this page see one failure illustration of the bushing shell offset on the rubber insert in the lower control arm. Compare failure to illustration of NOS (new old stock) Harris SILENTBLOC 62511 bushing.

THE FIX: An online examination of 1965 - 69 Corvair suspension parts indicates many vendors sell the problem (incorrect) bushings individually or in suspension kits. If your front suspension lower control arm bushing has failed, then it is suggested BEFORE purchasing new replacement bushings, visually inspected replacements at a vendor, or their online site from proper configuration. As of the writing of this article, the only solution is to use a NOS (New Old Stock - OEM) bushing or purchase a correct reproduction bushing from California Corvair part number CC06191B.

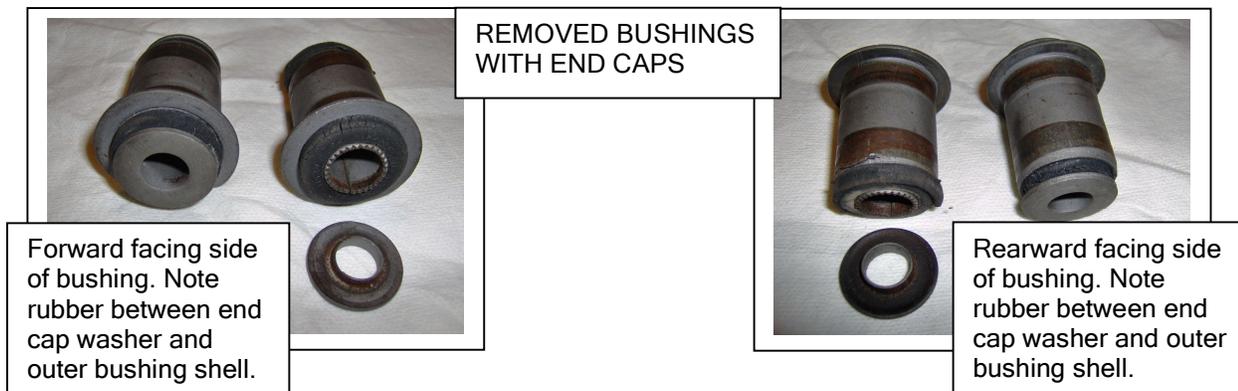
The correct design has rubber protruding on both sides of the bushing shell to the ends of the inner sleeve. See picture of used factory bushings removed from lower control arm with end cap washers. Like the NOS bushing pictured above, the rubber extends past the outer shell to the ends of the inner sleeve to prevent the outer metal shell from slipping to one side or the other that can cause the control arm to move against the crossmember. Page 2 illustrates the two different incorrect bushing observed online at different vendors.

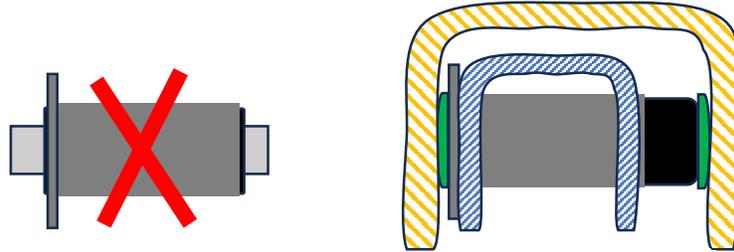
FAILED

The following illustration shows one incorrect bushing type some vendors sell that does not have a rubber core extending past the outer shell to the ends of the inner sleeve. This allows a gap between the end washer caps on the inner sleeve, and the rubber inside the outer metal shell. Eventually movement forces the rubber to slip in the shell and on the inner sleeve until the shell contacts the washer end caps and the lower arm contacts the cross member.

Incorrect rubber gap between sleeve ends and rubber core allow outer sleeve and rubber core (black) to slide over inner sleeve between end caps (green).

Lower arm (blue) typically moves off center against crossmember (orange) resulting in metal to metal contact.

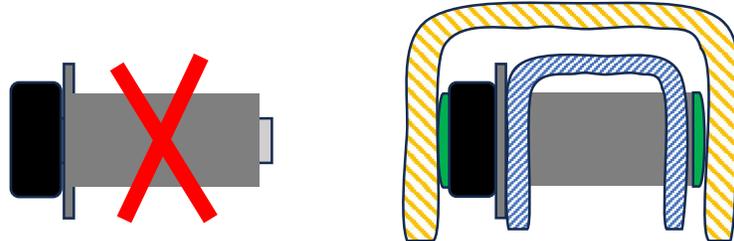
FAILED

The other incorrect bushing type found online has no rubber extending on one side allowing the end cap to contact the outer shell. This bushing causes the lower arm to be off center and contact the crossmember.

Incorrect rubber insert only extends out only one side. Other side outer sleeve moves and contacts end caps (green).

Lower arm (blue) contacts crossmember (orange) on one side resulting in metal to metal contact.

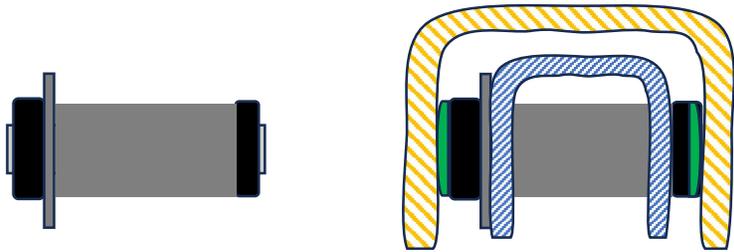
CORRECT

The following illustrates a correct bushing. At the time of this article only California Corvair sold this original style bushing. See illustration and note rubber correctly extends past outer shell to end of inner sleeve on both sides.

Rubber core (black) correctly extends past outer shell to ends of inner sleeve between end caps (green).

Lower arm (blue) centered between crossmember (orange) with rubber isolation on each side.
