## Rejuvenated Rampside

*Part 1: Though most have been forgotten, this 1961 Corvair 95 Rampside pickup gets treated to a ground-up restoration worthy of a trophy-winning Full Classic*

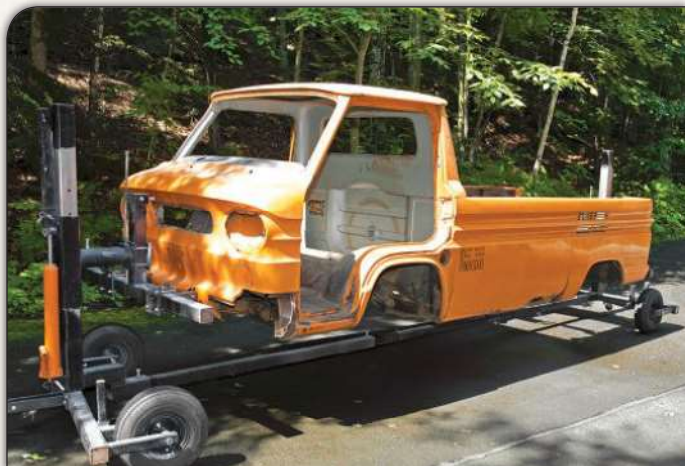
With the Rampside disassembled, it was mounted on a rotisserie so that it could easily be moved around the shop and worked on. The original Omaha orange paint had been the fleet color for the first owner, who had bad luck with the Rampside.

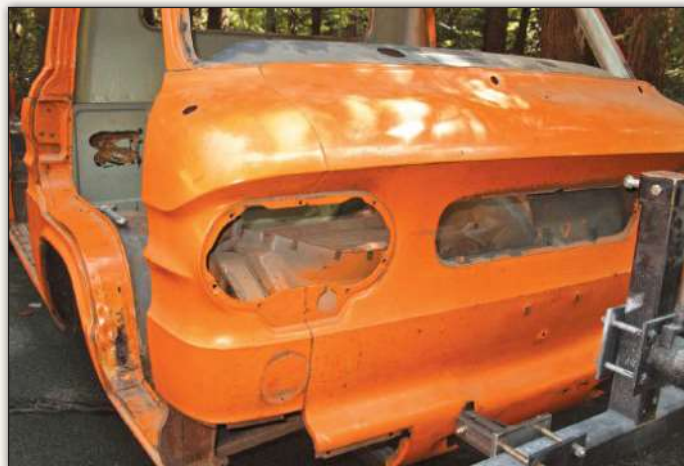
Proper restoration meant removing any and all components from the Corvair's unit-body chassis, including all doors, glass, lighting, wiring, suspension and undercarriage, the entire interior and all decorative trim.

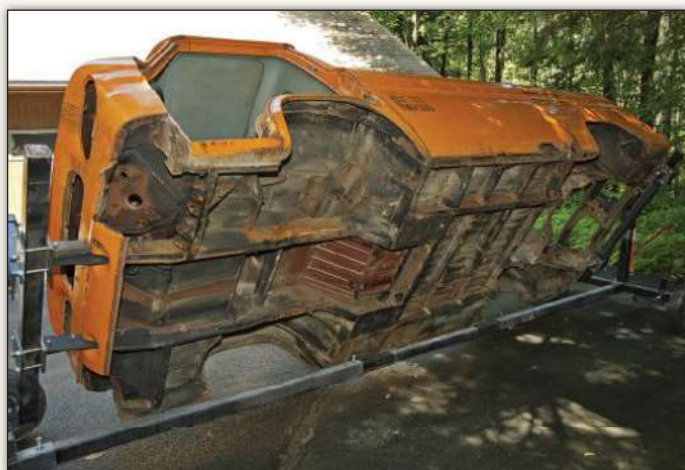
Despite being stored indoors for over 20 years, the Rampside still continued to corrode in some places. Though the rot was largely confined to the lower extremities, it also included the integrated frame pieces.

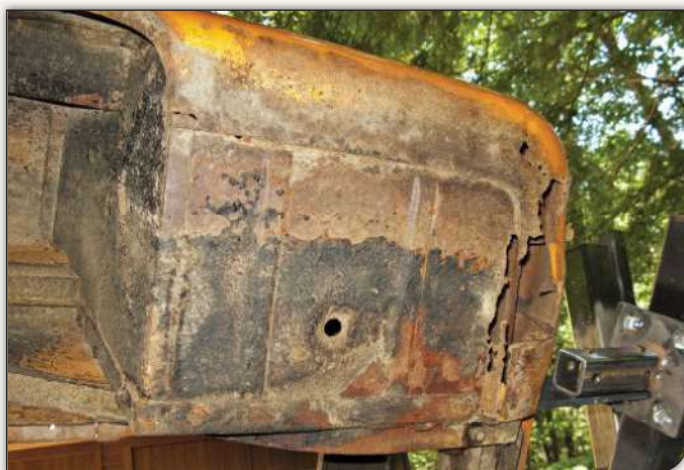
With substantial holes in the floor and no suitable reproduction or used panels to weld in, the restorers had to fabricate appropriate pieces to complete the body. Reproduction side panels, however, were available from his company, Clark's Corvair Parts.

very convoluted and complex panels made up of multiple panels, and luckily I had saved some of those. But, when it got into sections of the floor and sections of the frame underneath—that just all had to be fabricated. The wheel wells were okay. It's pretty much the floors and frame unit and braces underneath that had to be made."

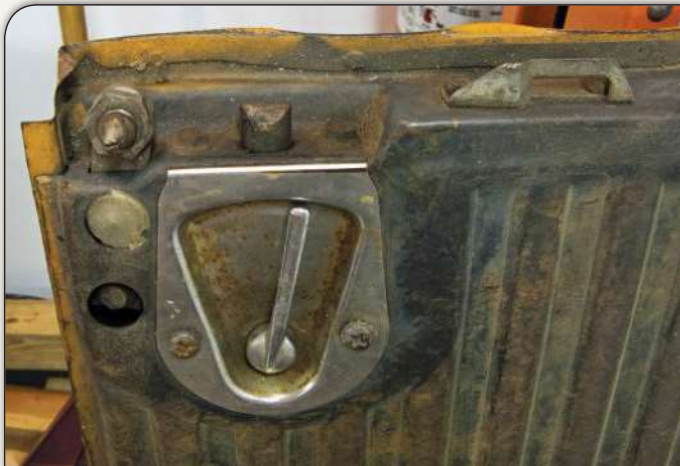
When restoring the ramp, which had to be disassembled, precise alignment of the guiding pin was critical, as the closed ramp provides an important structural component for the bed that would otherwise flex substantially when the pickup was moving.

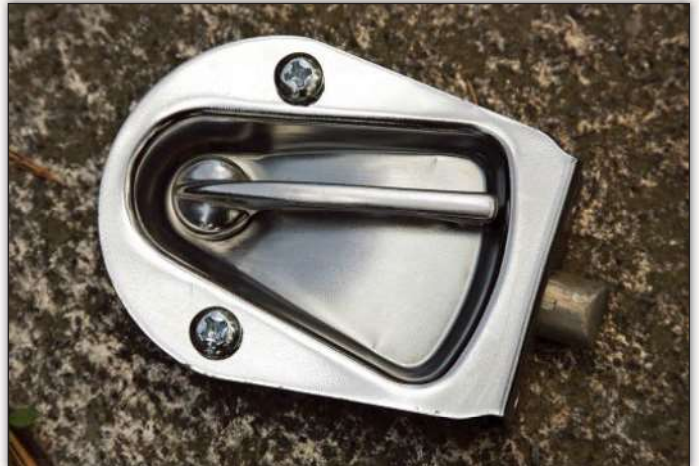
Though most trim components had held up well, the ramp latch had taken more than its fair share of weathering and hard use. The rechromed component shines better than new and operates flawlessly when opening the restored ramp.

Fortunately for Cal, most of the chrome was in good shape, but he did have to send the ramp and tailgate latches to D&S Custom Metal Restoration of Holyoke, Massachusetts, for replating. For the inside of that ramp and the rest of the bed, Cal wanted to have it as close to the factory hue as possible. "I got that color," he says, "by going back to my other 1961 Rampside that hasn't been on the road since 1971 and has always been inside in a dark environment. And that's the paint that I went by to try and match. It's a gray that has a tint of green, which is the way I mix it. I take a GM charcoal with a GM charcoal green and mix the two together."

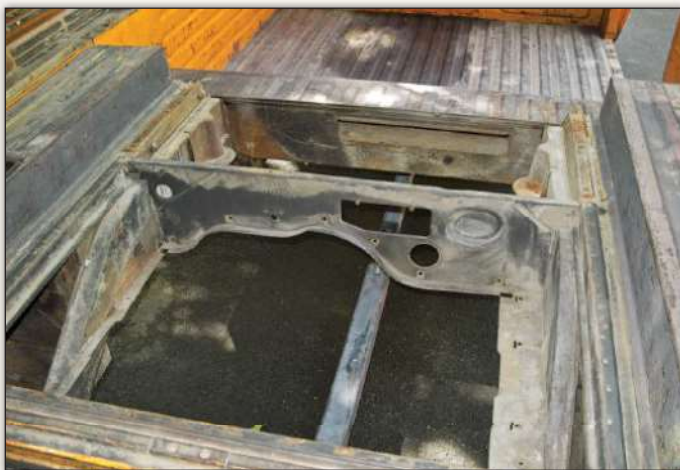
The engine bay, easily visible here with the bolt-in engine covers removed, sits high in the bed and behind the rear axle. It was largely solid, but much like the rest of the lower extremities, did require some work due to so much salt exposure.

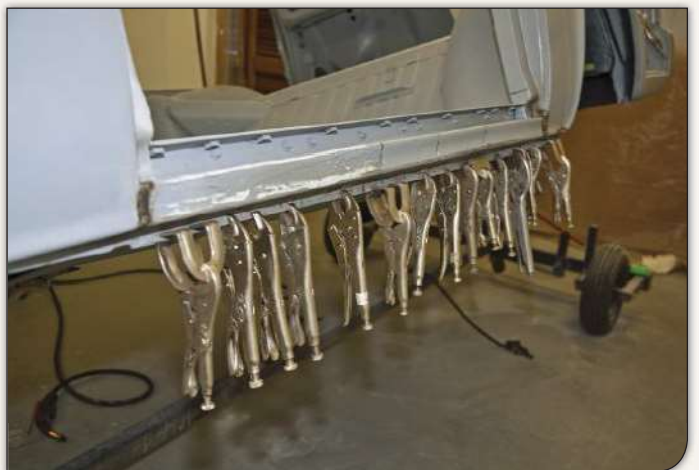
The Rampside's unique, mid-bed door gave the chassis an obvious weak point, the rocker panel essentially the only structure holding it together. More than a dozen locking pliers were required to keep the piece straight when welding it back together.

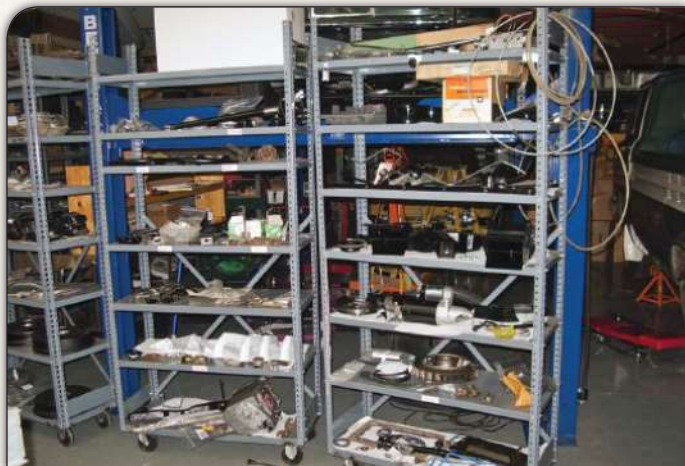
Organization is key to any successful restoration, but particularly one when a car is completely disassembled. Parts were organized onto heavy-duty roll-around shelves with each component labeled and organized accordingly on the appropriate shelf.

Cal had been down this road before with a 1957 Chevrolet convertible, so he knew the ropes. Anything and everything that came off the Rampside was labeled. Parts were grouped, such as for the interior, wiring, lighting and so forth, and those parts were all organized on heavy-duty rolling shelves that could be moved around the shop as needed. Any components that could be removed from the body were removed, including the cab doors, deck lid and ramp door, and all glass. Only the windshield, taken out years ago to test a gasket, was missing.

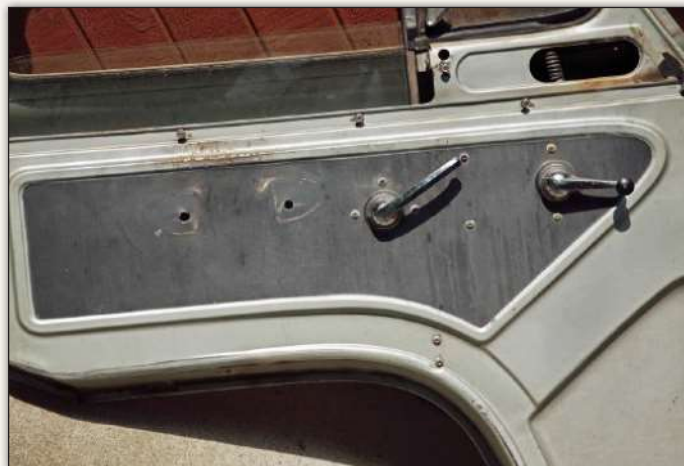
New England winters spare no steel. Even the doors required removal of some surface rust and complete disassembly and re-assembly. After removing all glass, polishing compound was used to brighten up each piece before re-installation.

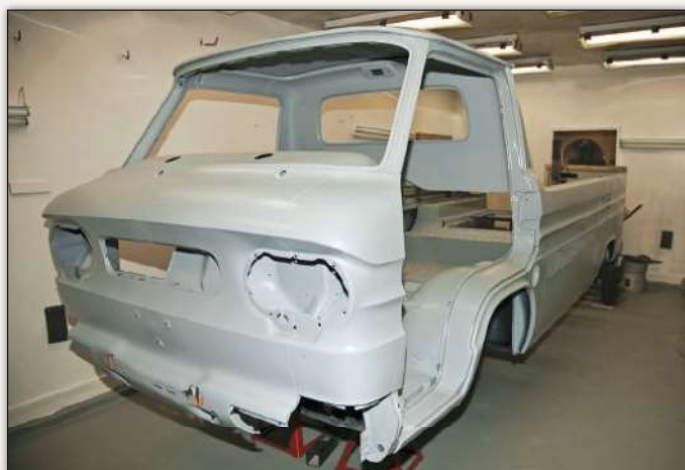
Three coats of Martin Senour 2K Primer Surfacer were each smoothed down with up to 600-grade paper. A final coat of sealer was applied before base colors were laid down. Very little body filler was used, no more than  $\frac{1}{16}$ th of an inch at the most.

Cal then hired Brandon LeBlanc of Westhampton, Massachusetts-based Big B's Autobody to assist with the completion of the bodywork. But Cal insisted on handling the DeVilbiss GTI spray gun himself. He first laid down three coats of Martin Senour 2K Primer Surfacer. Having block sanded on previous projects, Cal handed that job off to Brandon, who smoothed the surface with up to 600-grade paper. After applying a coat of sealer, he then laid three coats of Martin Senour Crossfire Platinum Base, first in the white for the side stripes and then in a shade that most closely matched Romany Maroon, an original Corvair color. After four coats of clear, Brandon finished flattening the surface with 1000- and then 2000-grade paper.

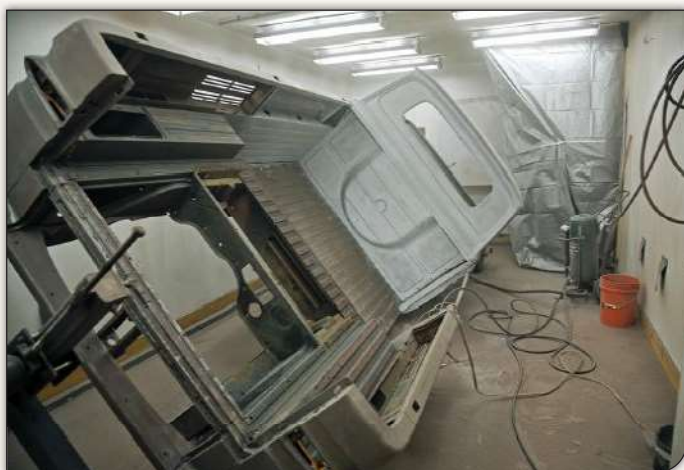
With its 360-degree access, the rotisserie allowed the undercarriage of the Rampside to be painted in a detailed manner, giving the once forgotten pickup a truly top-notch, bottom-up restoration.

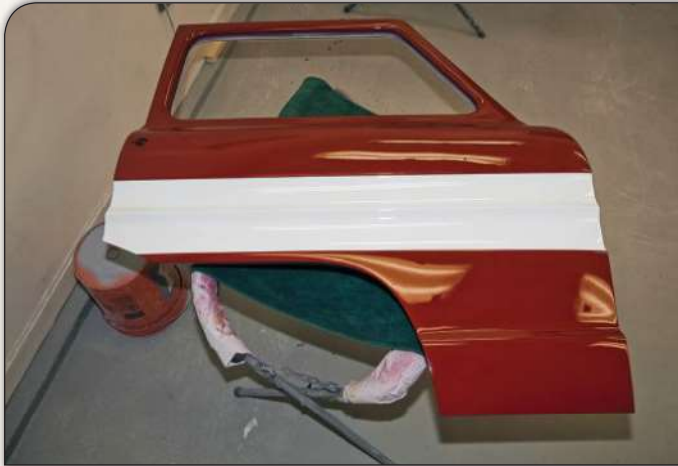
Despite Cal's insistence that working with doors is perhaps his least favorite aspect of restoring old cars, the Rampside's doors turned out as perfect as the rest of the body and continue to close properly after very careful alignment.

Despite very intimate familiarity with the Corvair and all its variants, final assembly of the body was not without its pitfalls. Not a big fan of working with doors, Cal reports that getting them hung properly was not an easy task: "I think my wife and I worked on the final door adjustment for hours it seemed. You would move it the absolute minutest amount, and the bottom would be out too much or in too much or back too

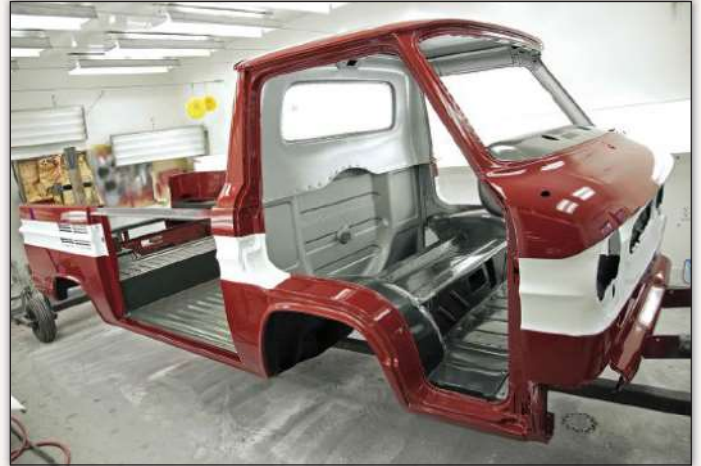
Three coats of Martin Senour Crossfire Platinum base were used for the white-and-Romany Maroon two-tone before they were top-coated with four layers of clear. All were painted at the owner's well-equipped home shop paint booth.

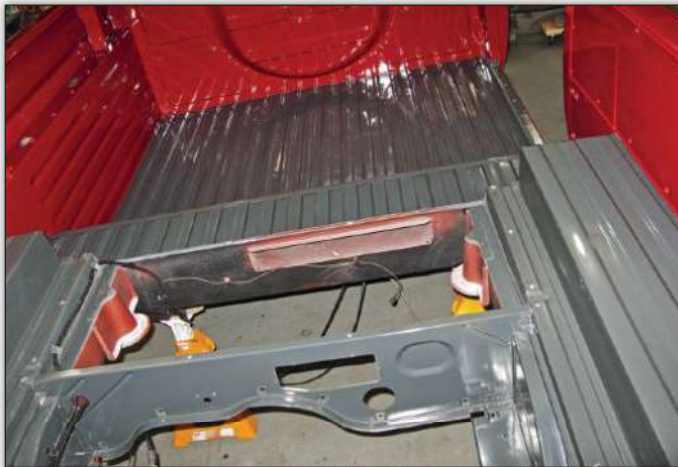
Matching the correct gray of the bed was no mean feat. It required finding an original bed that had been kept from too much exposure to the sun and other elements, and careful mixing of two GM paints: charcoal green and charcoal gray.

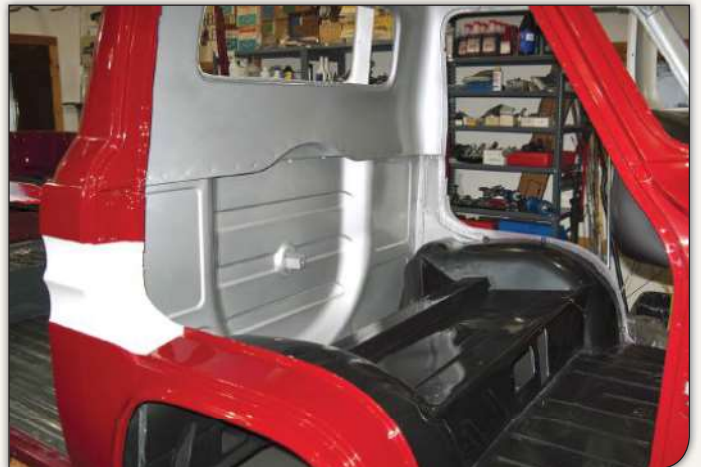
With the seats still removed, it is possible to see the extent to which the owner went to properly restore and refinish each and every surface of what was once merely a delivery vehicle, a working truck, but now is a bona fide concours Corvair.
