Refurbishing the 1965-69 Manual Transmission Shift Assembly
by Bob Nichols
Last Revision January 1, 2024

The following is about repairing the LM (1965-69) shifter assembly. Comments from Corvair owners suggest the LM floor shifter experiences greater wear vs. the EM floor shifter. The different EM (1960-64) shifter will not be discussed.

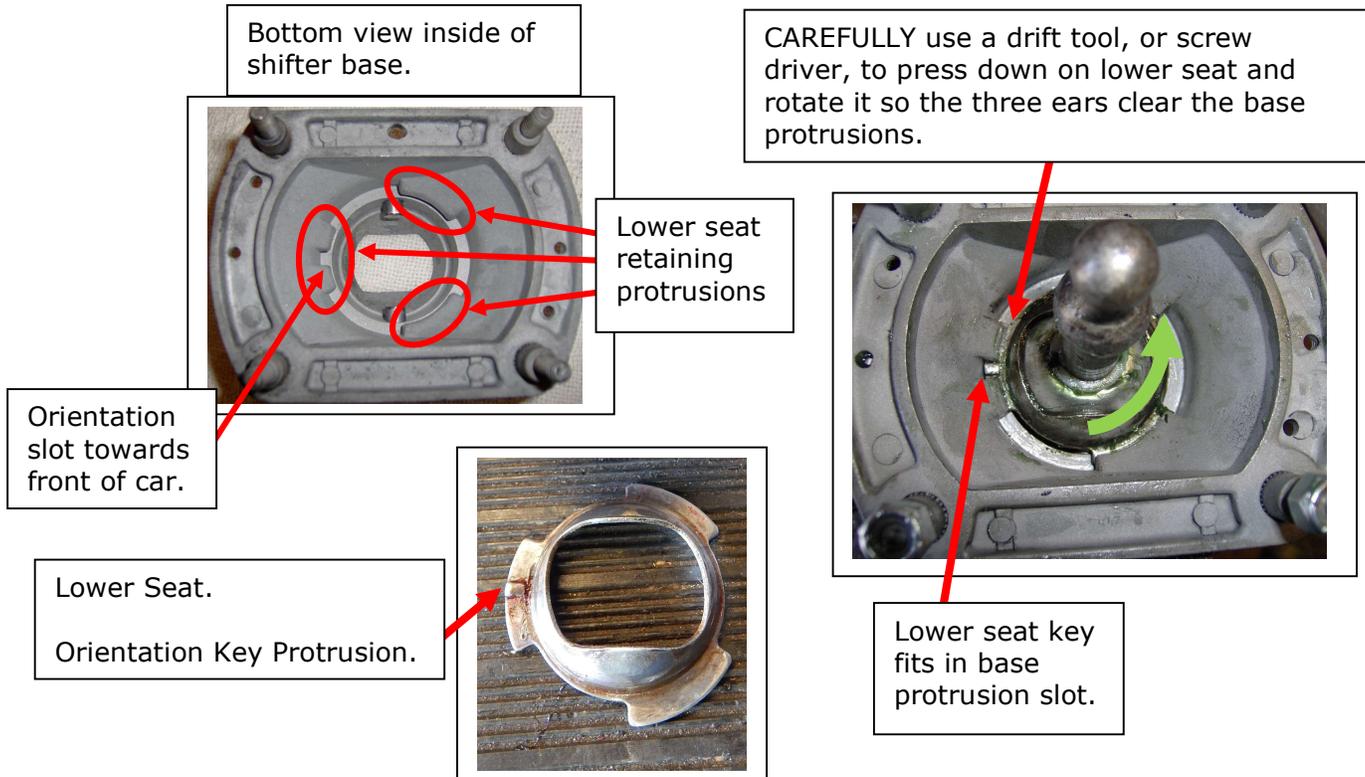
- **Lower Seat** - A circular plate has three extensions. The “seat” is retained under three protrusions in the base. **NOTE: the shifter lever assembly seat is under tension from a spring between the parts below the retainer. Exercise caution while dismantling the assembly.** The seat must be rotated until the three extensions are clear of the base protrusions. Refer to illustrations.

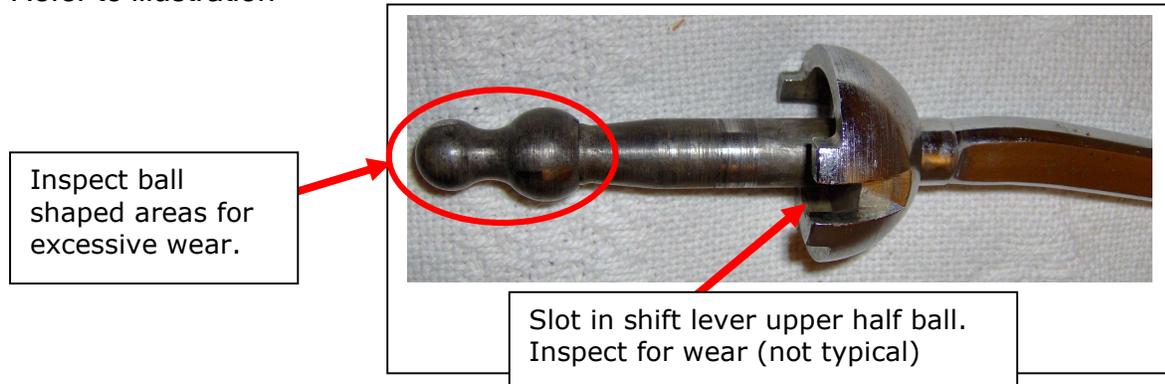
Floor shifter repairs - Depending on model, the shifter lever is either painted or chrome plated and may need to be re-plated. The shifter lever has a half ball with slots in the ball that is part of the pivot mechanism. The slots in the half ball fit over, and rotate on, pins in the shifter lever base. Refer to illustration -

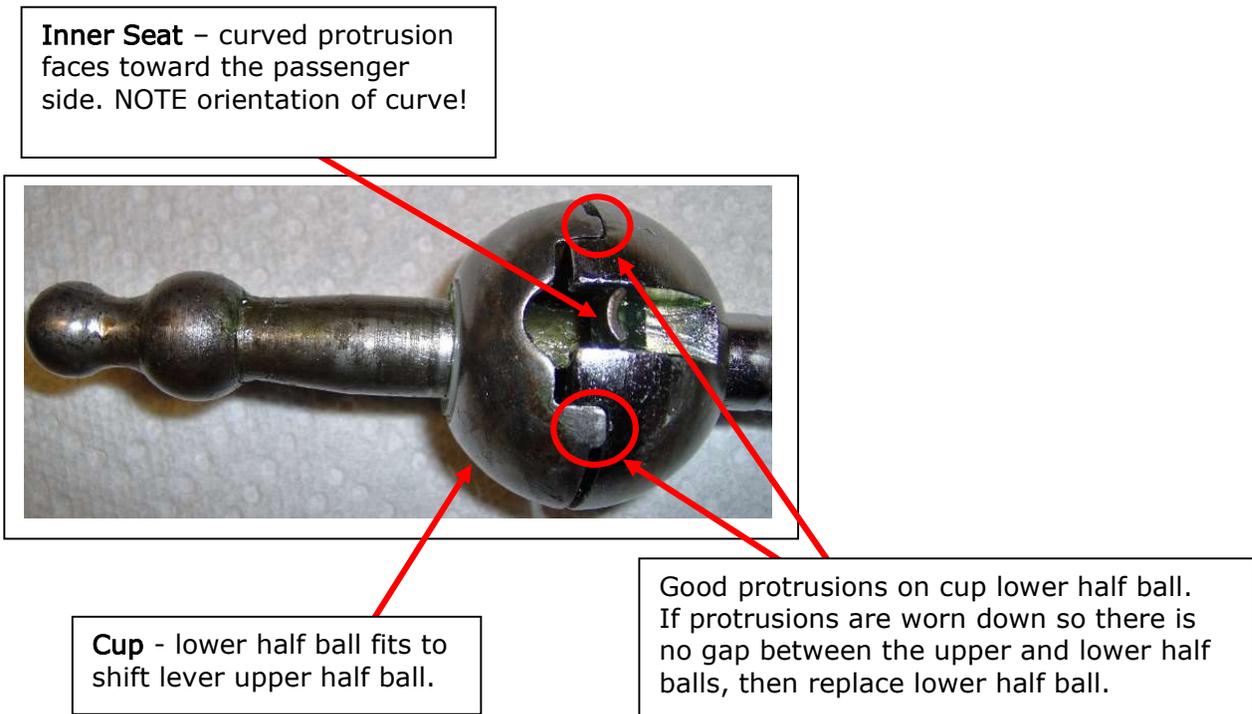
Internal seat and lower cup - Refer to the following illustration. The lower cup can be worn in areas indicated. A worn cup should be replaced with a good used part. NOTE: The cup can be repaired by welding on new material and machining it, but it requires skilled workmanship and a good part to use as a measuring reference.

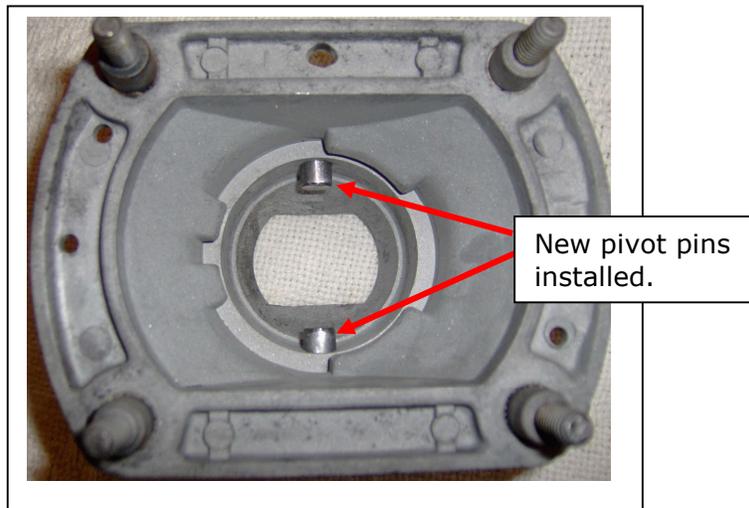
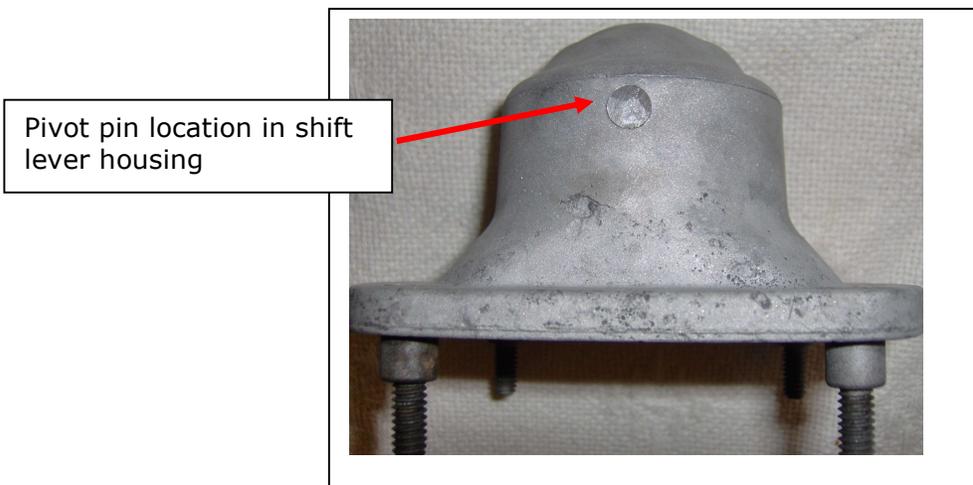
Shifter lever base --- The shift lever fits into an aluminum housing that contains two pins for the shift lever to pivot on. See illustration.

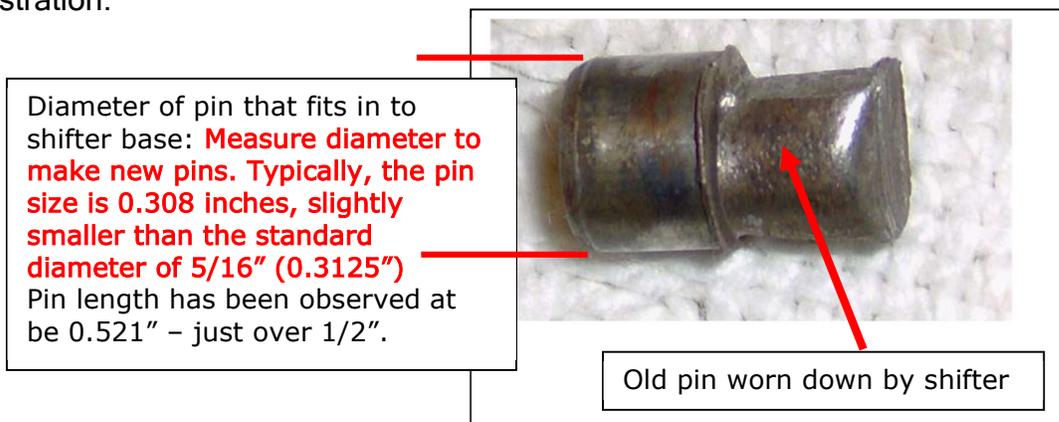
Worn shift lever pins can be pressed out of the aluminum base and replaced. See illustration.

NOTE: The shifter pins metal alloy is softer than the shift lever ball metal. **DO NOT INSTALL HARDENED STEEL PINS** since they will cause the shifter lever ball slots to wear. The shifter ball slots are difficult to repair without damaging the shift lever.

Several used pivot pins were examined. The typical diameter is 0.308" that is smaller than the standard rod 5/16" diameter of 0.3125". A soft metal 5/16" rod can be purchased to make new pins. Very little metal will need to be removed from the rod diameter to make a pin that fits snugly in the base housing. New pins SHOULD NOT REQUIRE EXCESS FORCE TO INSTALL. Excessive force can deform or crack the aluminum housing. The 5/16" metal rod diameter can be reduced using a lathe, but many use a simpler method of rotating the rod in sandpaper. Some use a hand drill; others rotate the rod on a work bench while applying an orbital sander to the rod. Once the rod diameter is reduced to allow the rod to snugly fit in the shifter housing hole, then cut the rod to produce a pin length of 0.521 +/- 0.003", just over 1/2" long. Press pins into the base housing without using excessive force.

NOTE: It is strongly suggested the shifter base holes NOT be opened to 5/16" to accommodate the standard rod diameter. Every time the pins are replaced the pin hole diameter in the aluminum base may increase slightly due to broaching from pressing in the pin. Once the hole gets larger than 5/16" a custom pin will need to be machined on a lathe to fit snugly.

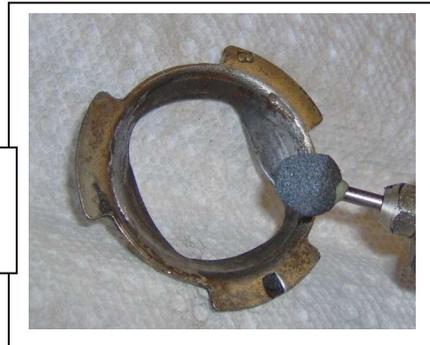
Lower Seat - When the shifter is used for long periods without being lubricated, the lower retaining seat can be worn. Inspect it and remove minor ridges and corrosion so the inner surface is smooth. If badly worn or corroded, then replace lower seat.

Remove corrosion and wear burrs from inside lower seat.

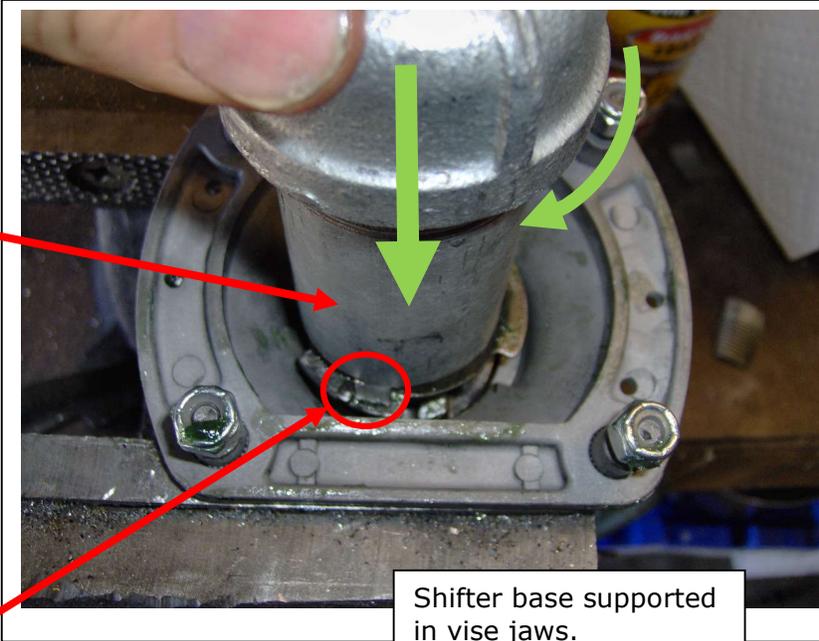
Select pipe (metal or plastic) that fits inside the base protrusions so the lower seat can be pressed DOWN against the spring tension and rotate the pipe and lower seat so the three extensions slide under the base protrusions. **NOTE: pipe is modified so it has a tab to push against the lower seat raised key to rotate the lower seat**

Rotate lower seat to push raised key under base protrusion.

Shifter base supported in vise jaws.

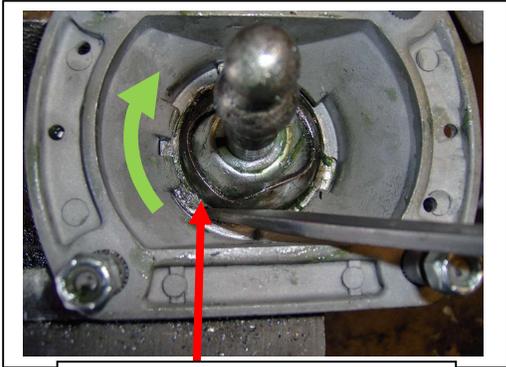
Complete rotation of lower seat to push raised key under base protrusion until key is in slot.

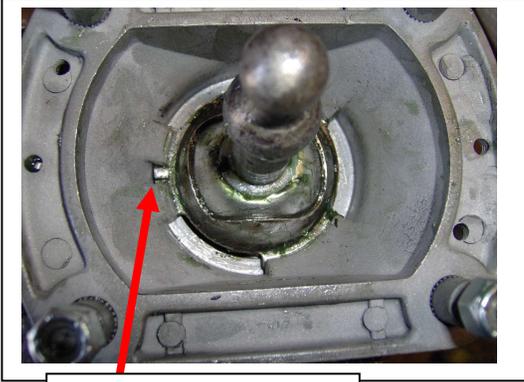
Lower seat raised key in base protrusion slot.

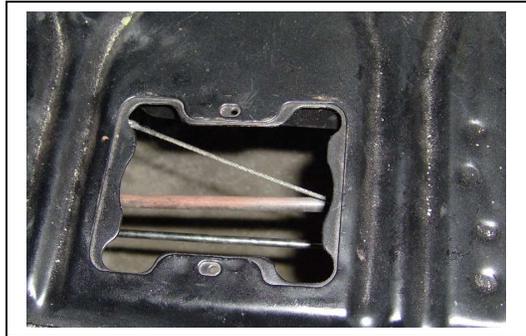
Floor opening.

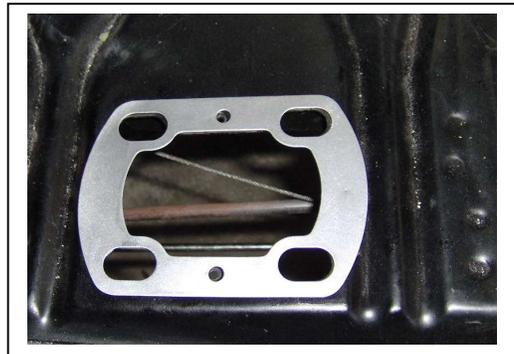
Thin steel shim on top of floor. It is often corroded. Replacement shim from vendors is plastic.

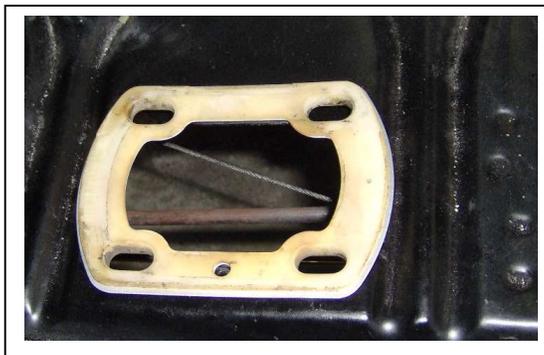
Plastic seal that sits on top of thin steel shim. Shifter lever and base sit on top of seal.

Note the elongated slots the shifter base fits into allow the base to slide fore and aft with the drivetrain movement.

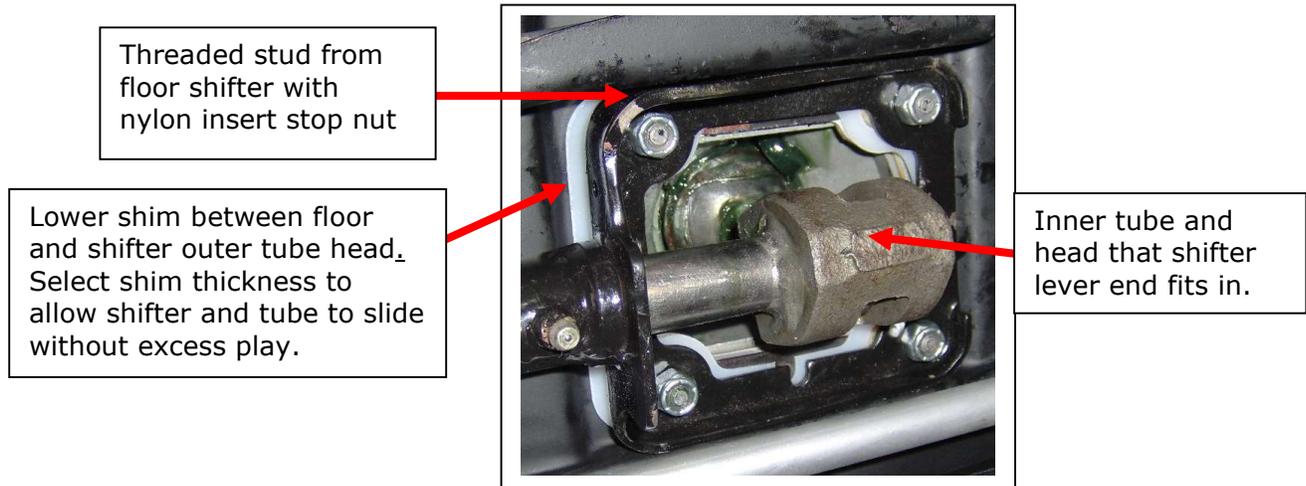
Four threaded studs protruding from the shifter base go through elongated holes in the plastic upper seal and thin shim, through the floor, into the shifter rod housing head. From below the floor, four nuts are installed on the four shifter threaded studs. Only part of the stud is threaded so the nuts will stop at the unthreaded stud shoulder.

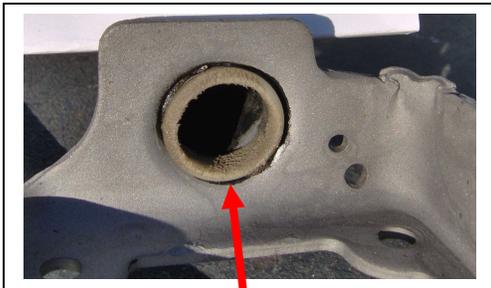
Front plastic bushing

- Remove the worn outer tube plastic bushings. See illustration.

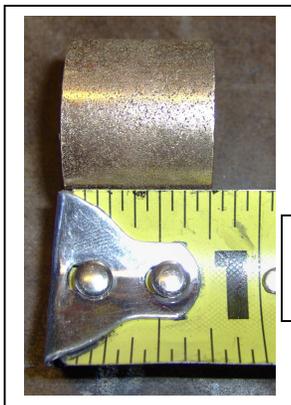
Example of brass or bronze bushing fitted inside outer tube.

- Replace the bushing on each end of the outer tube that support the inner tube with either plastic or brass.
 - Plastic bushings are easiest to install and available from Corvair vendors.
 - Brass or bronze bushings are an alternative. Corvair vendors sell them, or they can be purchased from a hardware supplier.
 - Brass/bronze bushing advantages are:
 - Greater durability and less play between bushing and inner tube.
 - Brass/bronze bushing disadvantage:
 - Lubrication required.
 - They often require honing to provide clearance between bushing and inner tube.
 - The brass/bronze bushing must be secured in the outer tube. Securing hardware must not protrude into the inner diameter which would bind the inner shift tube.

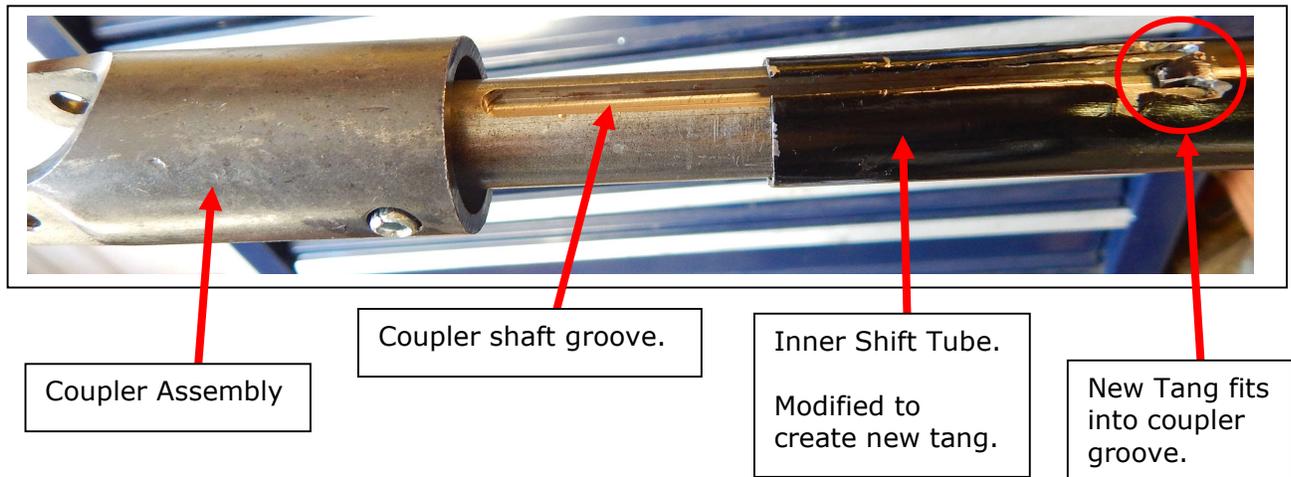
The shift coupler shaft has a groove in its shaft. The coupler shaft fits into inner shift tube that has a corresponding slot and an alignment tang. The tang fits into the coupler groove to align the coupler in the inner shift tube. This prevents the coupler from slipping and rotating out of place that could prevent proper gear selection.

If the tang is broken off the inner shift tube, then cut the tube to make a new tang (width equal to groove width in coupler shaft) and carefully bend it down. See illustration.

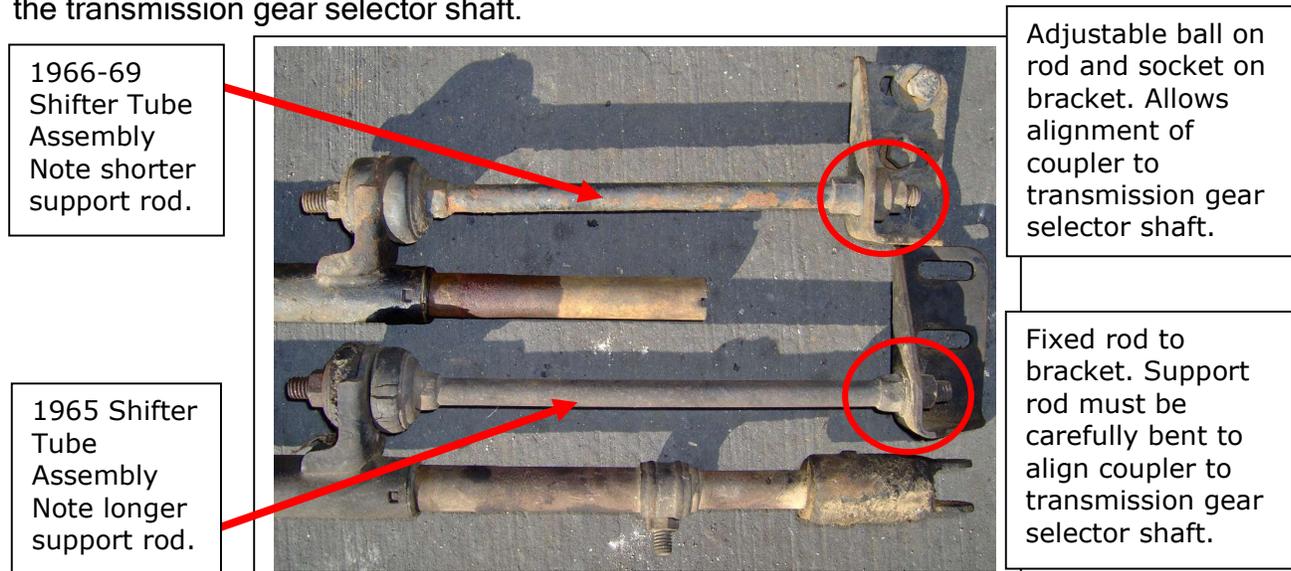
The shifter tube assembly rear support - The shifter and shifter tube assembly are connected to the transmission mounting bracket. The 1965 model year shift tube rear support is a one year only design. The revised 1966 - 69 transaxle required a change to the shift tube rear support. The support rod is a different length and is attached to the support bracket via a ball joint that allows the rod to be adjusted to align the coupler with the transmission gear selector shaft.

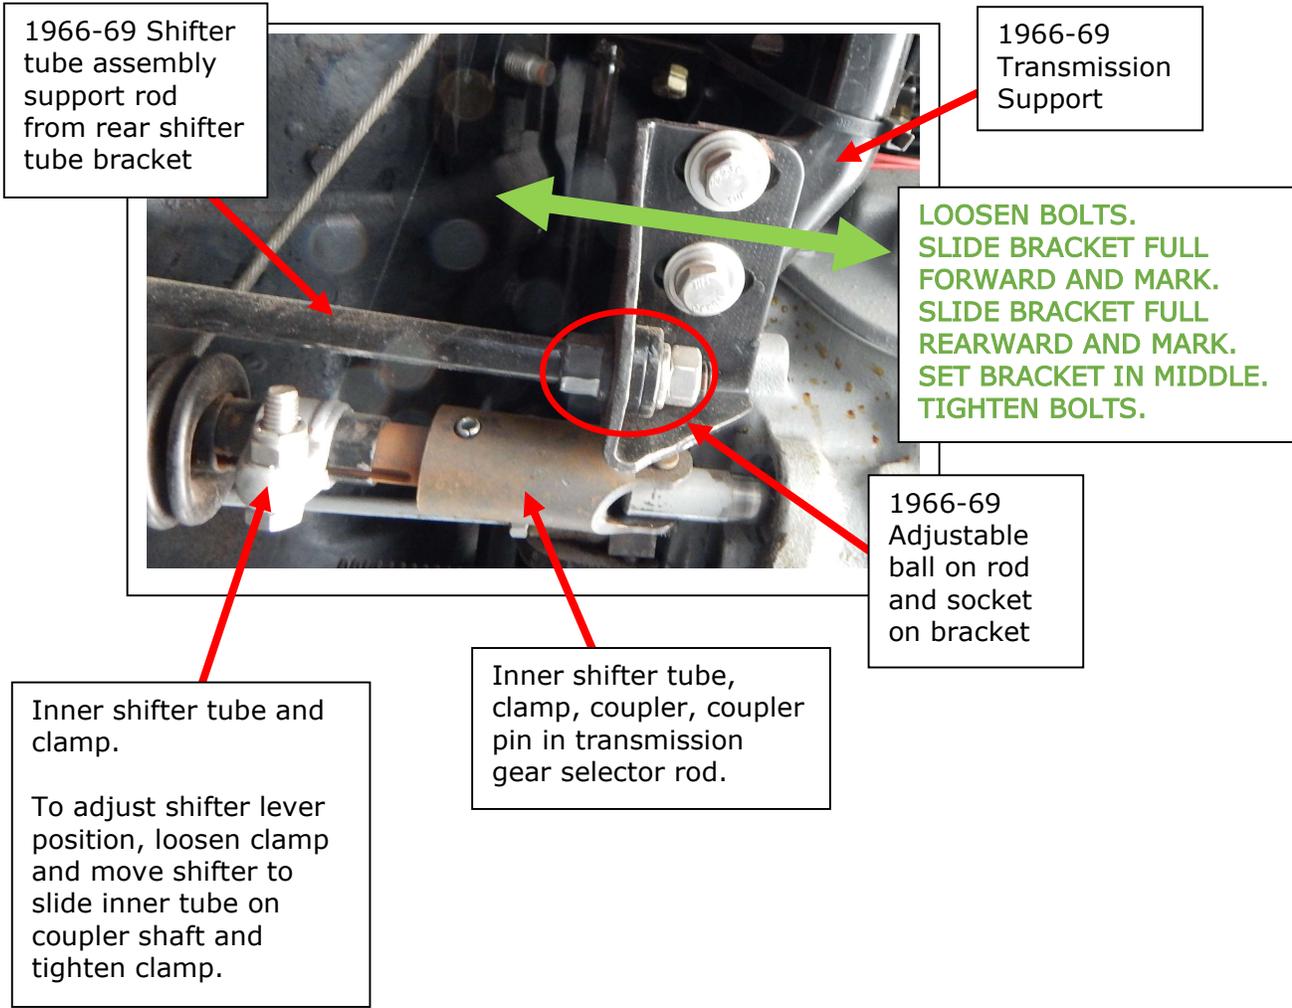
Centering the shifter and shift tube assembly at rear support - The LM floor shifter slides in the floor as it is connected to the transmission support. One issue is making sure the floor shifter is centered in the slots of the shifter plastic seal so the shifter can move fore and aft without hitting the shifter seal slot ends. Once the shifter and tube assembly are installed, loosen the rear shifter tube rod support that bolts to the transmission support.
